**US Army Corps
of Engineers**
Philadelphia District

Final Report

**Analysis and Monitoring of
Double Twisted Wire and Welded Wire Gabions
Cape May Canal
Cape May, New Jersey**

June, 2001

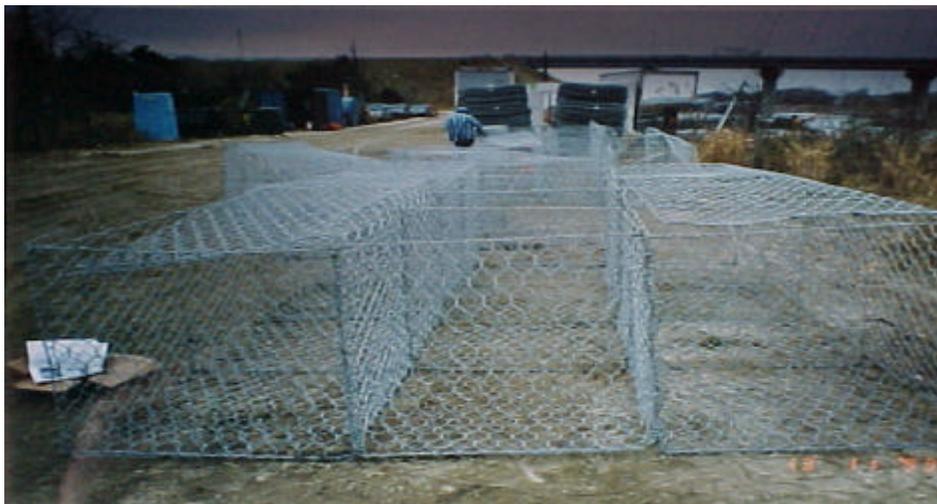
Assembled double twisted mesh gabion baskets, prior to placement

The twisted wire mesh gabions were delivered pre-cut and pre-assembled to the site. Top, toe, and mattress baskets were supplied with the sides, ends and diaphragms connected to the bottom face. Top and toe baskets were supplied in four-meter lengths, with the lids attached along one edge, and diaphragms at one meter spacing. Internal connecting wires were installed prior to filling procedures to prevent excessive bulging of the basket panels. The mattress baskets were supplied in 3-meter by 7 meter dimensions, and did not have pre-attached lids; roll out lids were provided. Mattress basket diaphragms were supplied at 1 meter spacing parallel to the canal and at 1.5 meter spacing perpendicular. Erection of the empty baskets involved unfolding and connecting the vertical adjacent edges.

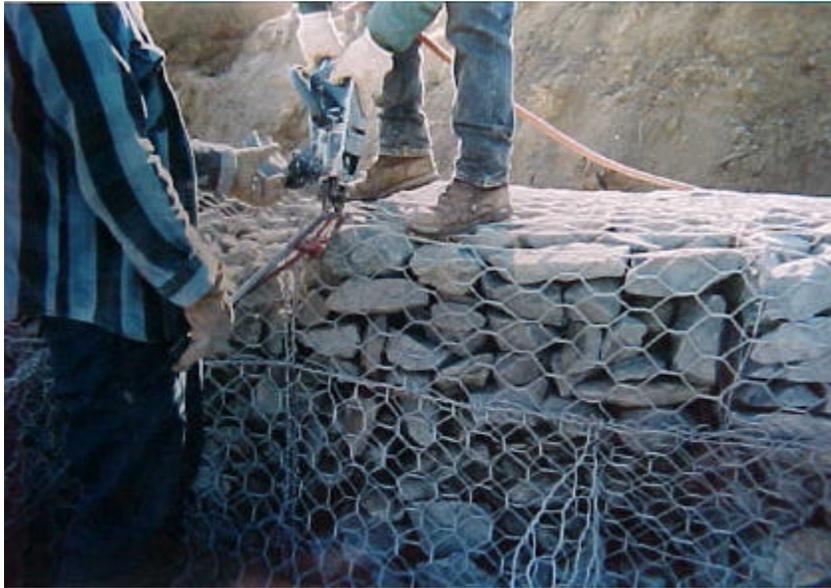
The clips were then tested for connections involving both empty and rock filled adjacent baskets, and closure of lids on filled baskets. After comparing the baskets in the test section to those fastened only with lacing wire, it was determined that the clipped baskets were not as tightly fastened and there was a larger potential for damage to the PVC coating.

Closing a twisted mesh top basket lid with locking wire fastener clips

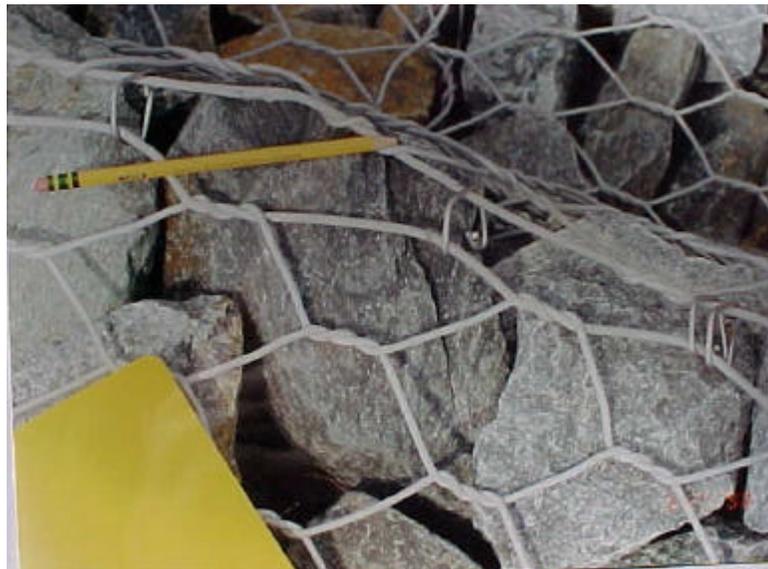
- The lids on the baskets closed with clips were not connected as tightly to the diaphragms as were the lids fastened with tie wire lacing. This was because the clips were larger in size than the two wires involved in the connection, and consequently left it loose.
- For the case of the rock filled top and toe baskets, large gaps remained in some places between the outer edge of the basket lids and vertical front panels.

Connection along the edge of a top basket lid and side panel with locking wire fastener clips

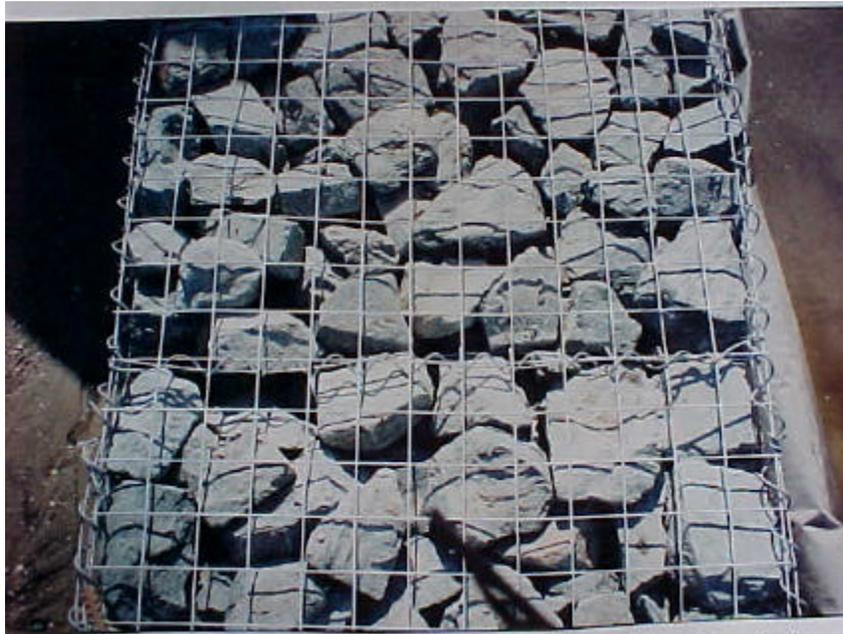
Welded wire mesh toe basket, prior to slope basket construction. Note the horizontal spiral binder connection between roll out lid and single diaphragm and along side panels. Geotextile fabric on right side of basket.

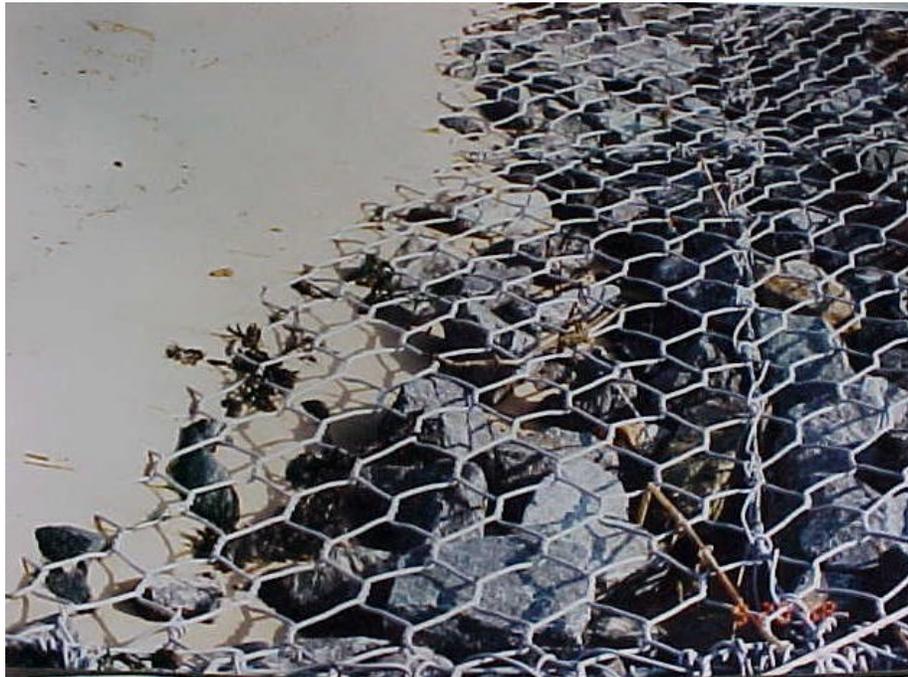
- Along the length of most of the revetment, the sloped mattress baskets below the high water line were noted to have voids up to 8" deep in some areas between the mattress basket lids and the rock beneath. Since this area is where the baskets were exposed to the effects of boat-generated waves and tidal currents, it appears that these forces exacerbated rock settlement resulting in more displacement of rock and the large voids. The presence of rocks that were smaller than 4" (as discussed in "Gabion Rock") also contributed to the voids.

Voids in the twisted mesh mattress basket in the wave zone resulting from displaced rock.

To eliminate the disadvantages of using the spiral binders as discussed above on rock filled baskets, additional hand sorting and leveling of the rock as placed in layers is recommended. This is particularly necessary on the exposed outer layers of rock where eliminating sharp or angular rocks from contact with the wire mesh would reduce the chances for damage to occur to the PVC coating as described above. Hand placement would also increase the volume of rock that can be packed into the baskets as well as decrease the amount of expected rock settlement.

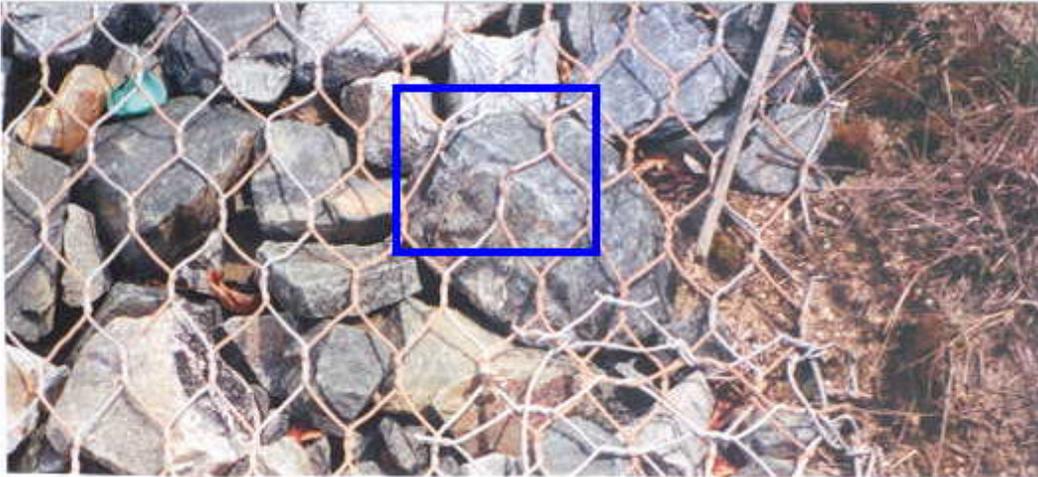
- In some localized areas, the practice of overfilling the baskets with rock beyond the recommended 2" resulted in breakage of the wire mesh over time, particularly in areas where the outer rock layer included rock(s) that were larger than 8".

Break in twisted wire mesh top basket resulting from increased stress from protruding rock greater than 8" in size.

The control of the gradation of rock fill is important in retaining the rock inside the baskets due to the mesh opening dimensions and for the need to minimize voids which increase the risk of settlement. Problems were encountered on this project in obtaining consistent rock gradation quality as discussed above in "Gabion Rock". Recommendations by gabion manufacturers and the contract specifications were very direct: the rock shall be between 4" and 8" in size. In the future, the following language will be included in District specification requirements for sizing rock fill in order to provide a more concise limit on what will be acceptable:

"Rock supplied as fill for the gabion baskets shall be such that no rock is retained on the 8" sieve and minimal rock shall pass through the 4" sieve (see table below). The 0 to 5 percent passing the 4" sieve shall only include fines, sand, and quarry spalls incidental to mechanical handling and transport of the rock. Sizes of gabion rock shall be such that at the time the stone is mechanically dropped into the baskets an overall even distribution of stone sizes is achieved. Individual loads or parts of loads may be rejected if material does not meet the specifications."

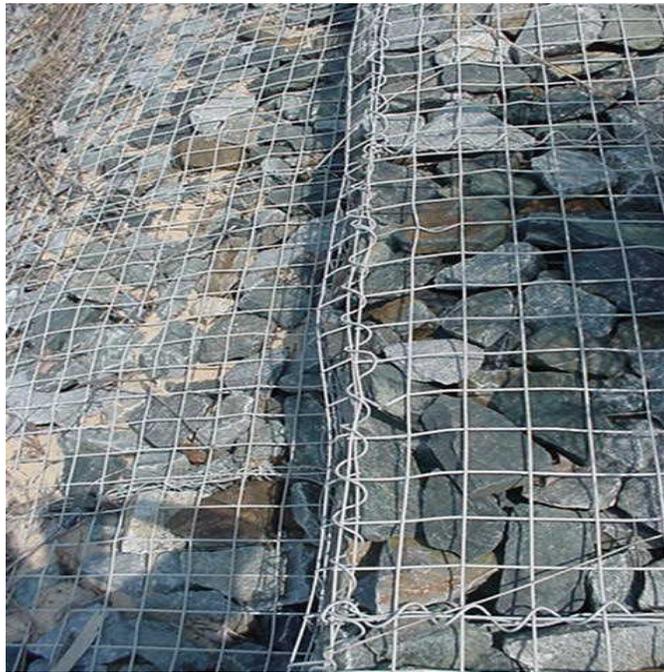
- The wire and PVC coating on the spiral binders (primarily along the outer edge of the lids of the top baskets with side panels closest to the canal) showed consistent damage. This occurred on approximately 50% of the spirals along this edge for the length of the top baskets. The exposed wire was minimally corroded. The spirals themselves were deformed from their original twisted shape, although still intact. This damage is probably due to the loads associated with pedestrian traffic and from work performed in and around the adjacent disposal area, since no such damage was evident on the vertical connections on the front of the baskets that were also fastened using spirals. This damage to the spiral binders was also noted on the diaphragms connected to the top basket lid but was not as prevalent, since the spiral binders there were generally connected closer to the lids than those on the outer edge of the top baskets. Spiral binders used on the mattress basket lids were generally in good condition, also because they are secured close to the lid mesh.

Damage to spiral binder on top basket.

(3) The upper half of the spiral binders used on the top connection of lid and side panels on square baskets (not covered by other baskets or backfill) remain above the top of the basket lids since they retain their rounded shape. This leaves the spirals and PVC coating more vulnerable to damage from external loads or abrasion such as would result from pedestrian traffic.

The potential for the spiral binders to become damaged as described above in paragraph #3 should be considered when evaluating potential locations to construct welded wire gabions. As an example, (in hindsight) due to the location of the revetment on this project adjacent to a dredged materials disposal area, use of spiral binders should have been limited to assemble empty baskets and for connections between individual empty basket units. Lacing wire remains the preferred method of fastening rock filled welded wire gabion baskets as well as twisted mesh baskets, especially for fastening lids (until stainless steel spiral binders become available). Providing the lacing wire with a different color PVC coating as mentioned in the twisted wire mesh gabion section would also be an improvement for welded wire gabions.

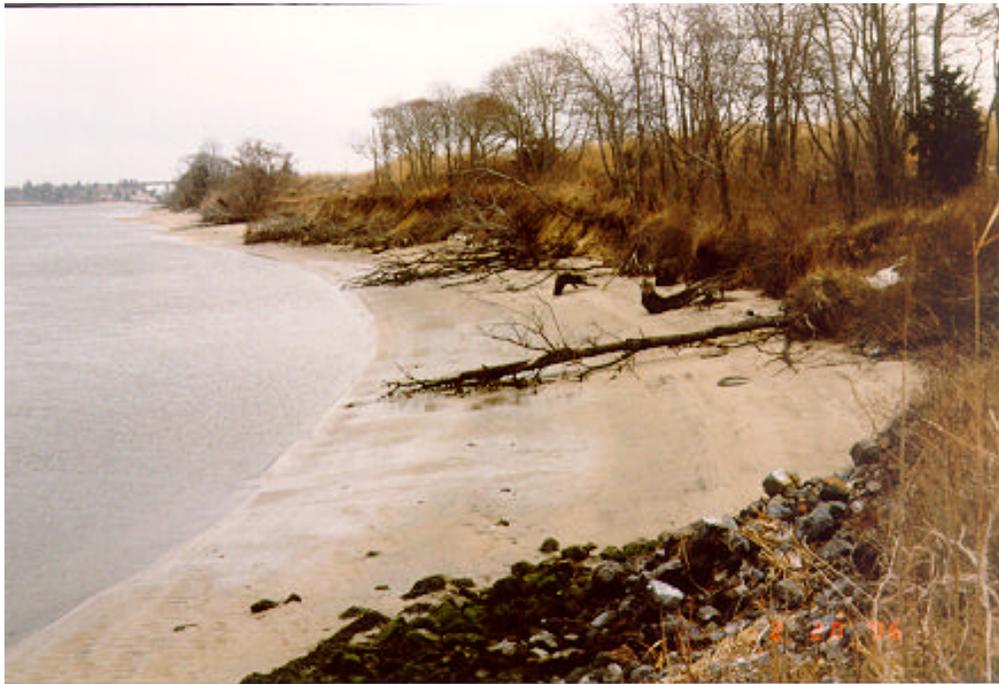
Cape May Canal project site prior to construction looking East

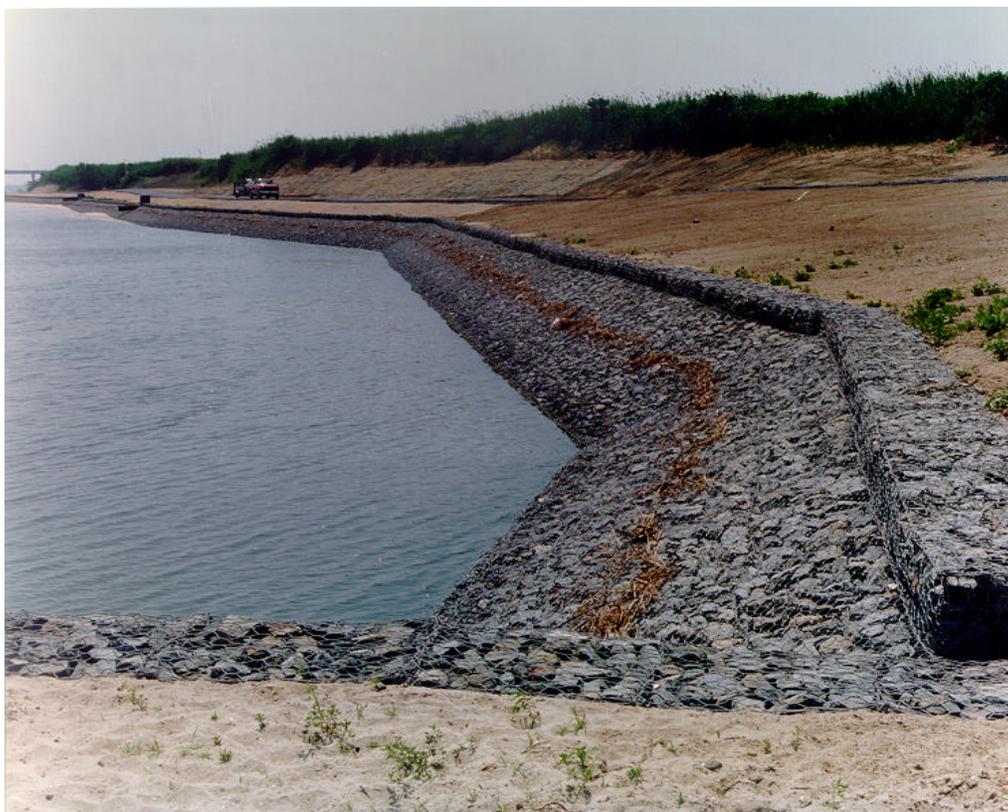
Completed gabion basket revetment, post-construction; showing the twisted wire mesh portion of the revetment from the same location.

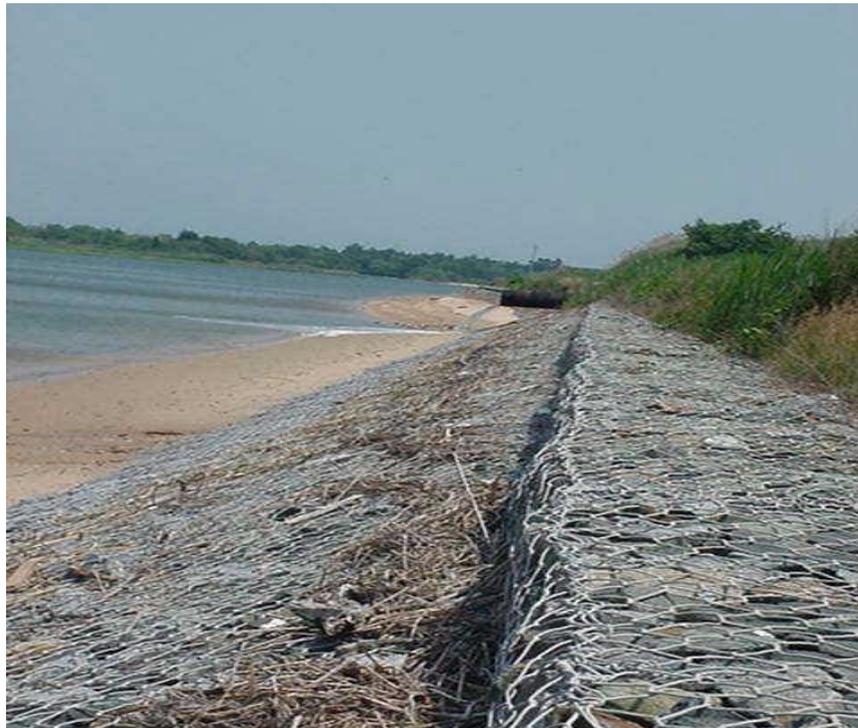
Twisted mesh gabion revetment, 3 years post construction, facing east.

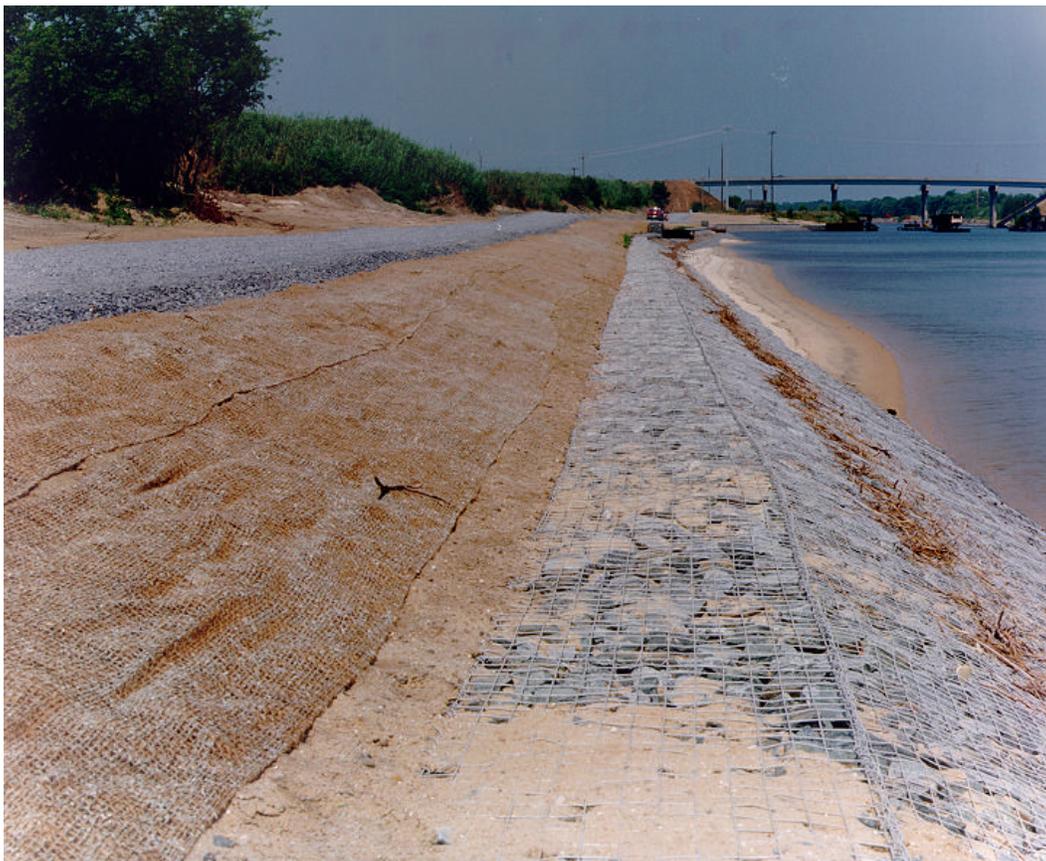
Completed gabion basket revetment, immediately post-construction; showing welded wire mesh portion of the revetment looking west. Access road and disposal area in background.

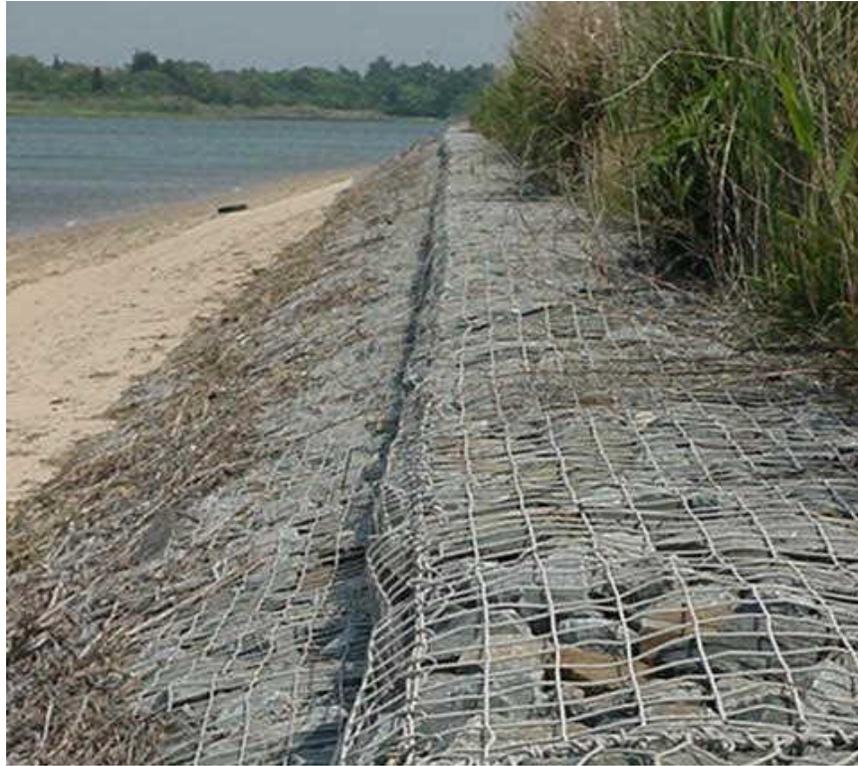
Welded wire gabion revetment 3 years post-construction, facing east
